**123 Easy Street**  
Piedmont, CA  
March 8, 2018 - 12:00 pm  
Report Number - 180308-123 Easy Street

This Report Prepared for  
**Joe and Jenny Customer**

Inspected by: Star Inspection Group, Eric Meyer  
Member: American Society of Home Inspectors® (ASHI)  
Member: International Code Council (ICC)

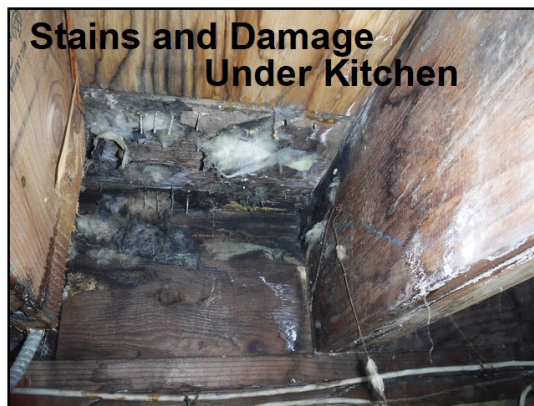
We observed stains on a few portions the subfloor area framing and sheathing, apparently indicating previous water entry or leakage.

*Moisture stains indicate previous water penetration. Stains are commonly found around bathroom and kitchen waste piping and at the building perimeter, and may indicate previous leakage that has since been repaired. Any indications of active leakage*

*or moisture-related damage should be promptly repaired by a qualified contractor.*

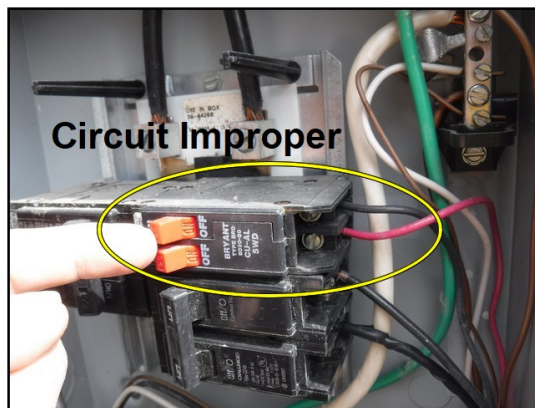
We observed improperly-wired, multi-wire branch circuits. The circuit's hot wires are on the same poles. The circuit lacks proper handle ties. We recommend the improperly installed multi-wire circuitry be corrected by a qualified electrician.

*Multi-wire branch circuits are pairs of 120-volt circuits that share a common neutral wire. To prevent overloading the neutral, the pairs of hot wires must originate from opposite poles in the panel (so there is 240-volt potential between them). This condition can typically be corrected by relocating the wires to different breakers within the panel.*

*When two breakers are used to protect a single 240-volt circuit, the breaker switch handles should be mechanically connected to operate in unison. A simple connector can be installed by an electrician to ensure that both breakers trip at the same time. This requirement includes multi-wire branch circuits such as the combined circuits for a dishwasher and a disposer.*

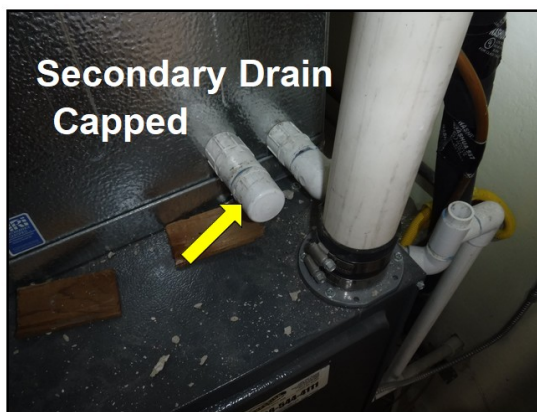
The air-conditioning air handler, located at the furnace, has condensate drain piping. The air handler's secondary drain outlet is capped; we recommend a secondary condensate drain line be installed to prevent damage should the primary drain become clogged.

*A substantial amount of water or condensate will flow from the coils when an A.C. or Heat Pump system is operating. The discharge piping for this condensate should be sloped and supported in the same manner as any other drain piping, and should discharge into a plumbing fixture or other approved location. The drain should be checked periodically to ensure that water flows from it when the air conditioning system is in*

*operation. The absence of water at the condensate drain, commonly caused by clogged or improper piping, may allow water to spill inside the evaporator and damage the equipment. Interior air handlers with condensing coils are often located in above-ceiling spaces, and should have a second condensate drain to prevent damage if the primary drain becomes clogged. Water sensing alarms can be placed in the overflow pans to signal that the primary drain is not functioning properly and condensate is flowing into the secondary pan.*
