**123 Easy Street**  
Piedmont, CA  
March 8, 2018 - 12:00 pm  
Report Number - 180308-123 Easy Street

This Report Prepared for  
**Joe and Jenny Customer**

Inspected by: Star Inspection Group, Eric Meyer  
Member: American Society of Home Inspectors® (ASHI)  
Member: International Code Council (ICC)

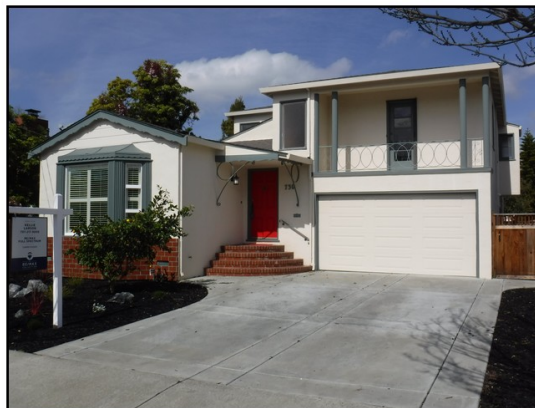
This report describes the building as viewed from the street. The building site appears relatively level. The sky was clear at the time of our inspection.

We were informed the building was constructed in 1941.

Modifications have been made to the building since its original construction. We recommend a permit history be obtained from the local building department to determine if modifications to the building were made with proper permits.
